Fraunhofer Institute for Integrated Systems and Device Technology IISB

Non-Destructive Localization of Electric Active Defects

Lock-In-Thermography

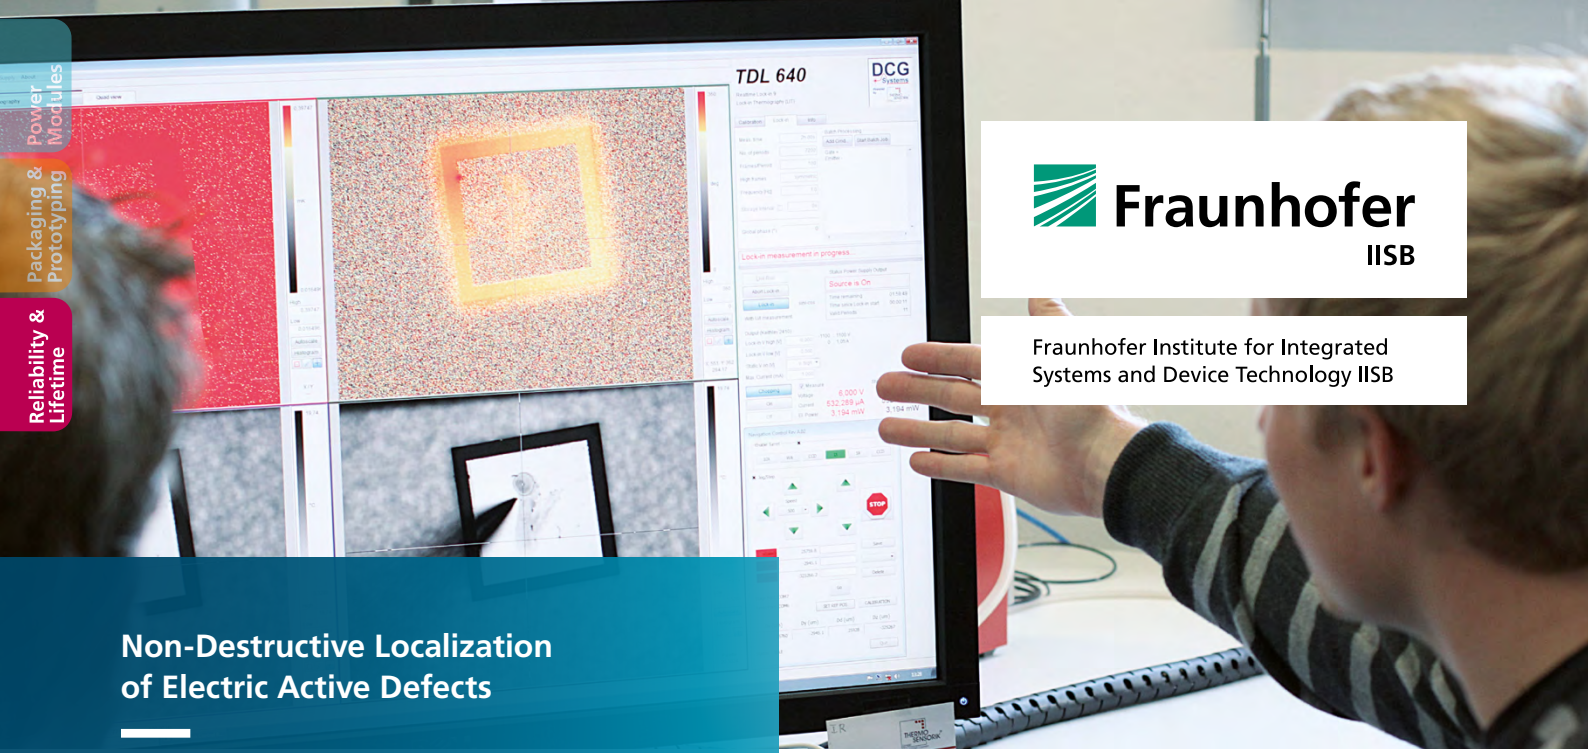
Lock-In-Thermography in action © Fraunhofer IISB

- The device under test is pulsed with the rectangular voltage by arbitrary Lock-In-Frequency (typical: 1 Hz to 25 Hz)
- Electrical defects dissipate thermal power
- Thermal power heats up the surface
- Measurement of infrared signal with infrared camera
- Acquisition of amplitude image as well as resulting time dependent step response (phase image)

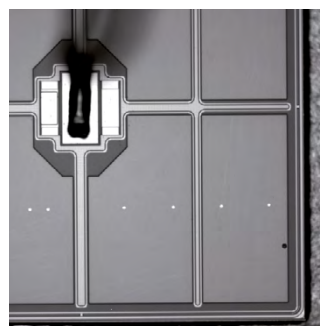
Optical microscopy of IGBT © Thomas Götz / Fraunhofer IISB

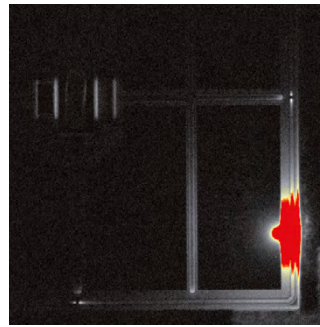
Lock-In-Thermography amplitude of IGBT © Thomas Götz / Fraunhofer IISB
